## Atomic Force Microscope Observation of Growth and Defects on As-Grown (111) 3C-SiC Mesa Surfaces

Philip G. Neudeck, Andrew J. Trunek<sup>1</sup>, and J. Anthony Powell<sup>2</sup>

NASA Glenn Research Center,

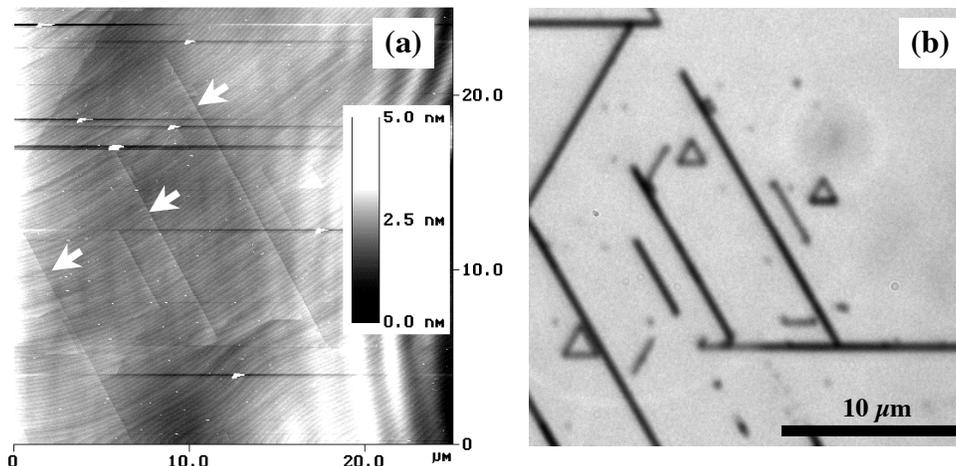
**Fig. 1:** Stacking faults on a defectively grown 3C-SiC heterofilm surface revealed by (a) AFM of as-grown surface and (b) post-oxidation optical micrograph.

We have previously reported that SD's threading a 4H-SiC substrate mesa subsequently result in a defective 3C heterofilm, and that the presence of SF defects can greatly enhance 3C heterofilm growth rate [1-3,5]. Fig. 1a shows an AFM of a small region of the as-grown epitaxial surface of a defective 3C-SiC film grown on a 4H mesa threaded by a SD on Sample 1. A pattern of 0.25 nm height steps generally flows from the upper left corner with downstep direction toward the lower right of the Fig. 1a AFM image. Superimposed on the 0.25 nm step pattern are a series of line features (some denoted by arrows in Fig. 1a), most of which are sub-0.25 nm (i.e., sub-bilayer) height perturbations in the surface. Fig. 1b shows an optical micrograph of the same region following over 5 hours of dry thermal oxidation. The dark lines visible in Fig. 1b are well known to arise from enhanced oxidation that occurs where SF's intersect the surface of a 3C-SiC film [8]. Given the exact correspondence of the pattern of linear features in Figs. 1a and 1b, we conclude that SF's can be observed by AFM on as-grown 3C-SiC films. SF features were also observed by AFM on additional samples, including some Sample 2 mesas.

The vast majority of steps observed by AFM on as-grown 3C surfaces were 0.25 nm (i.e., a single Si-C bilayer) in height. Macrosteps were occasionally observed on mesas with SF defects. Most macrosteps formed when 0.25 nm 3C growth steps piled-up along a SF. An example of such pileup can be seen in Fig. 3b of [5]. However, most SF's, including those shown in Fig. 1, did not produce macrosteps. Because growth steps in Fig. 1a flow across the SF's, instead of

emanating outward from the SF's, we conclude that the faults shown in Fig. 1 are not a primary nucleation source of new bilayers on this 3C-SiC mesa surface. However, it is worth noting that we have observed enhanced inward growth of new bilayers from mesa edges for some instances where SF's intersect the sidewall edge of a 3C mesa [5]. Given the variety of behaviors noted above, further studies are clearly necessary for better understanding of SF's in the 3C-SiC film growth process. It is important to note that the majority of 3C-SiC heterofilms grown by step-free surface heteroepitaxy (on SD-free 4H/6H mesas) are free of SF-defects [1-4].

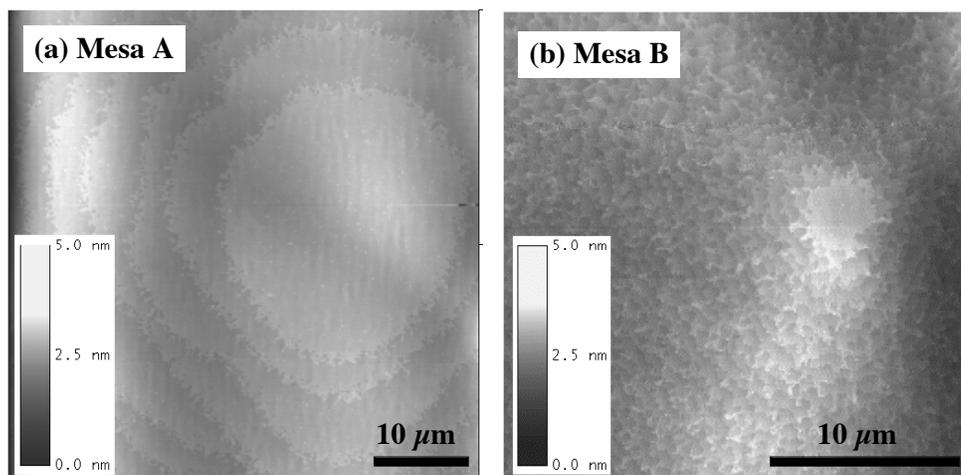
**Fig. 2:** AFM scans showing the topmost terraces from nearby (a) Mesa A and (b) Mesa B on the same wafer following higher supersaturation growth Run 2A. Both step patterns consist of concentric steps with jagged edges, but the step density is close to 10X greater for Mesa B.

AFM measurements revealed significant differences in step structure between growth under higher and lower supersaturation conditions. Fig. 2 shows two examples of step structure observed on nearby mesas (Mesa A and Mesa B) after higher supersaturation Run 2A. Both step patterns have very rough edges and are generally concentric with the topmost terrace residing in the interior of the mesa shape. However, Mesa B clearly shows a much higher ( $\sim 10X$ ) step density than Mesa A.

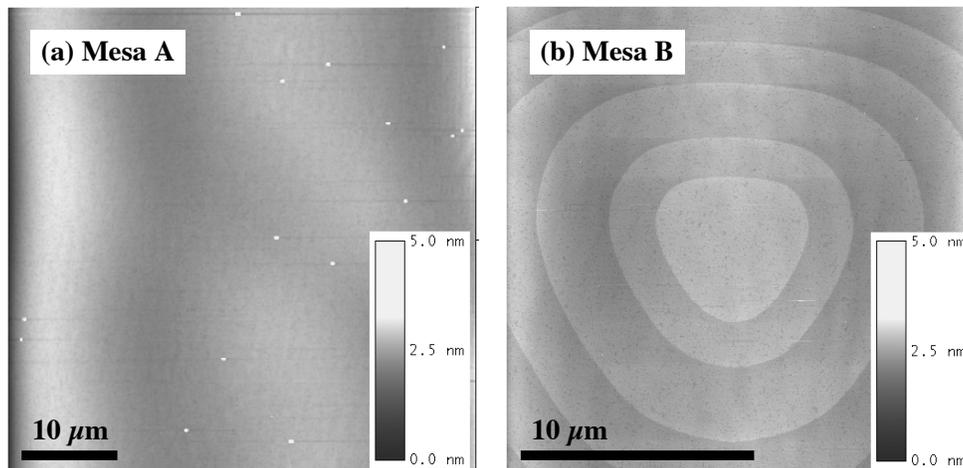
**Fig. 3:** AFM scans showing the same Mesa A and Mesa B of Fig. 2 following lower supersaturation growth Run 2B. No steps were detected anywhere on Mesa A. The concentric step pattern of Mesa B is consistent with bilayer growth by defect-assisted terrace nucleation.

Fig. 3 shows AFM scans of the same mesas following a short-duration low supersaturation growth Run 2B. As shown in Fig. 3a, no surface steps were detected on Mesa A. Thus, terrace nucleation was effectively suppressed, enabling the first reported formation of a step-free 3C-SiC mesa surface. In contrast, Mesa B (Fig. 3b) shows a well-ordered concentric pattern of 0.25 nm high steps. The concentric step pattern and higher step density of Fig. 3b is consistent with our previous observations of defect-assisted terrace nucleation on a very thin 3C-SiC growth surface [5]. We hypothesized that dislocations (threading edge) lower terrace nucleation energy leading to the observed concentric step pattern, but transmission electron microscopy (TEM) studies are not yet complete [4,5]. Most of the mesas observed at this stage were step-free (Fig. 3a), or exhibited far lower step density than shown in Fig. 3b.

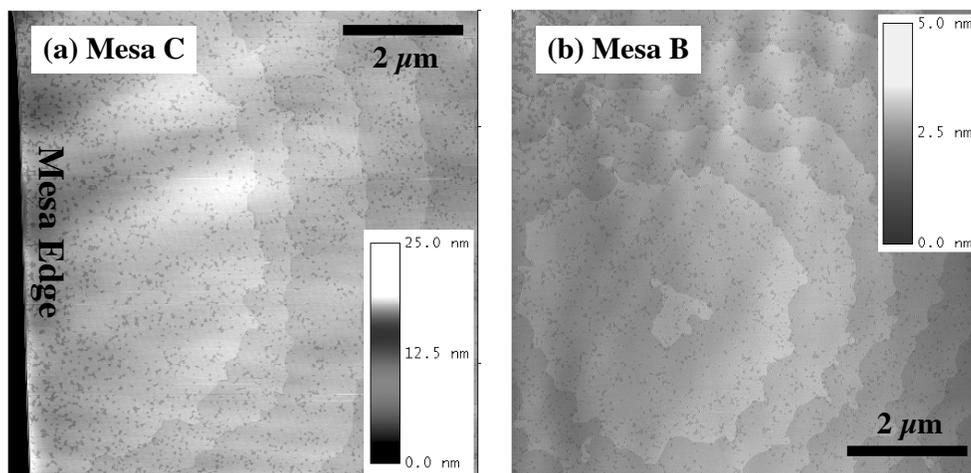
**Fig 4:** AFM scans showing the topmost terraces from two nearby mesas following higher supersaturation growth Run 2C. The topmost terrace shown in (a) on Mesa C emanates from the side edge of the mesa, whereas the topmost terrace shown in (b) on Mesa B arises in the interior presumably due to defect-assisted nucleation.

Following substantial additional growth under higher supersaturation conditions (Run 2C), a rough step structure was again observed (Fig. 4). Under higher supersaturation conditions, nuclei of larger size are more likely to form on terraces prior to joining the main stepfronts [9]. The higher reactant concentration should facilitate more rapid stepflow expansion of existing nuclei and steps. These factors would favor a much rougher observed “non-equilibrium” stepfront expansion, consistent with our observations. Growth at lower supersaturation, where terrace nucleation is effectively suppressed, maintains a much smoother “equilibrium” stepfront. Under these conditions, we surmise that mobile surface adatoms are able to diffuse to fill kink sites in the slower expanding stepfront, thereby enabling the smooth stepfront structure.

In a significant number of cases after Run 2C, the top of the step pattern was observed to originate from mesa edge regions. Fig. 4a (Mesa C) shows one example of this behavior. The observed trend for new bilayers to proceed inward from mesa edges on thicker 3C films suggests that enlarging 3C mesa sidewall facets may increasingly impact the evolution of thicker 3C crystals. An examination of the crystal structure of 3C-SiC reveals that all mesa sidewall/edge facets will have a higher percentage of surface carbon atoms than (the 0% of) the (111) silicon-face of the mesa top surface. The reported nucleation probability of carbon-terminated SiC surfaces is substantially higher than for silicon-terminated surfaces [9]. Therefore, we propose that growth of new 3C crystal material (i.e., nucleation of new bilayers) on mesa edge/sidewall facets should occur more readily than on the Si-face top surface. As 3C mesa film thickness increases, the area of 3C edge/sidewall facets increases. Thus, we believe that it is possible that

mesa edge/sidewall facet growth may begin to impact evolution of thicker 3C mesa crystals, even when edge/sidewall facets have much smaller surface areas than the mesa top. Further studies are needed to experimentally verify or refute the proposed edge/sidewall growth model. In other cases, nucleation (and therefore the topmost observed terrace) takes place in the interior region of the mesa top surface. Fig. 4b shows the topmost terrace of Mesa B, so we surmise that nucleation is defect-assisted in this case.

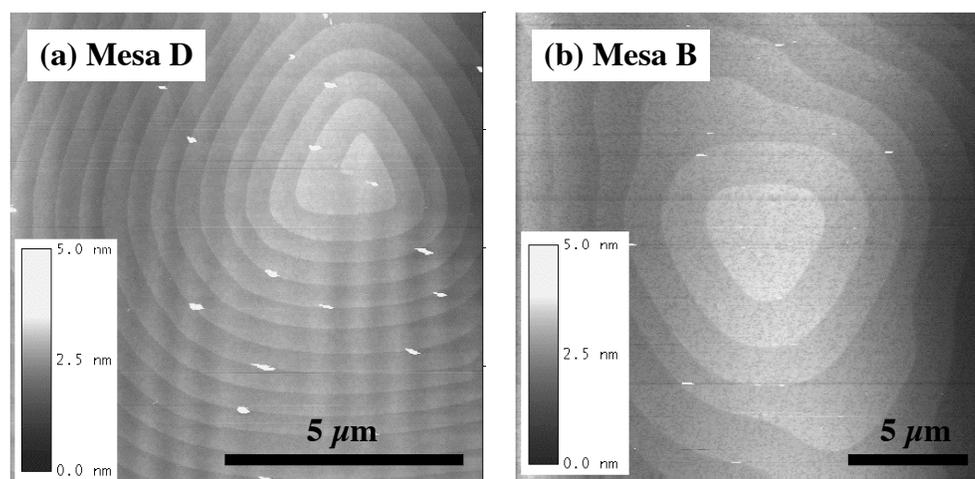
**Fig. 5:** AFM scans showing the topmost terraces from two mesas following lower supersaturation growth 2D. 0.25 nm height steps provided by (a) spiral stepsource from dislocation with  $1/3$  c lattice parameter screw component, and (b) defect assisted terrace nucleation on the same Mesa B from Figs. 2-4b.

Fig. 5 shows two examples of the topmost terrace regions on mesa surfaces following the final short-duration lower supersaturation growth (Run 2D). Quite interestingly, Fig. 5a reveals that bilayer height (0.25 nm) triangular-shaped stepfronts originate at a spiral stepsource. By analogy to spiral growth observed at screw dislocations in 4H-SiC [3,6,10], we surmise that either a pure screw or mixed dislocation has formed in the 3C-SiC film. From the spiral, we

deduce that the Burgers vector of the axial screw component of the dislocation is 0.25 nm, 1/3 the 0.75 nm c-axis repeat distance of the 3C polytype [10]. We believe that this is the first published report of such a step structure observed on 3C-SiC. Because a screw dislocation is a continuous kinetic source of new growth steps, terrace nucleation is not required to support growth of thicker films. Therefore, the observed 3C-SiC step density and vertical growth rate should be highest for the spiral case, compared to growth where new 3C-SiC bilayers must first be initiated by thermodynamic terrace nucleation [5]. Indeed, the lateral density of bilayer height steps shown on Mesa B (Fig. 5b), grown by defect-assisted nucleation, is more than 3X smaller than the kinetic step density evolved from the spiral on Mesa D in Fig. 5a. The formation mechanism for the 3C-SiC spiral defect is unknown at this time.
